**Flood Control Project Maintenance  
Levee Inspections**  
**LMA District Cover Sheet**  
**Spring 2018 Levee Inspection Results**

**Reclamation District No. 0341 Sherman Island**

**Spring 2018 Levee Inspection Results**

**Levee Inspection Report By Mile - Spring 2018**

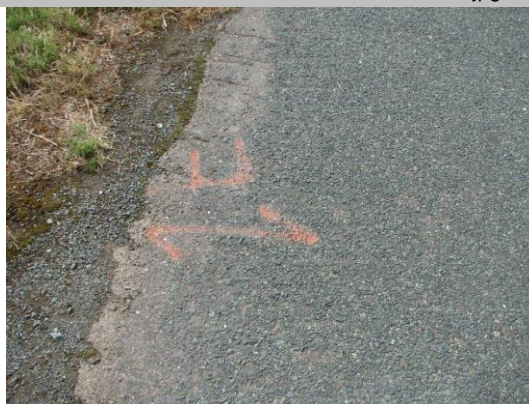
Photo 2 of 3 : UCIP\_SP\_2018\_52253\_37646.jpg

Underground Service Alert (USA) markings on road shoulder.

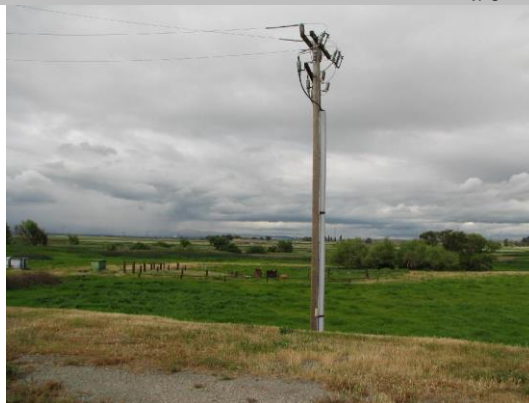
Photo 3 of 3 : UCIP\_SP\_2018\_52253\_37645.jpg

Power pole located on LS aligns with crossing.

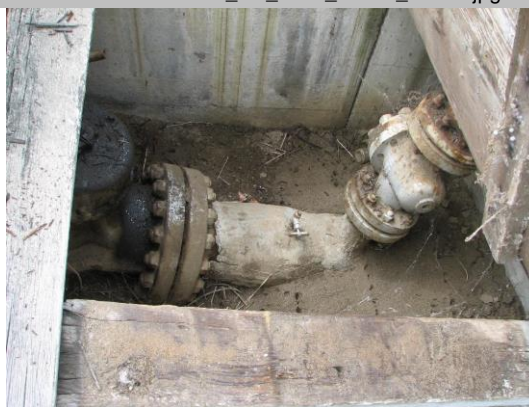
Photo 2 of 3 : UCIP\_SP\_2018\_52256\_37672.jpg

Inside view of vault located on the LS.

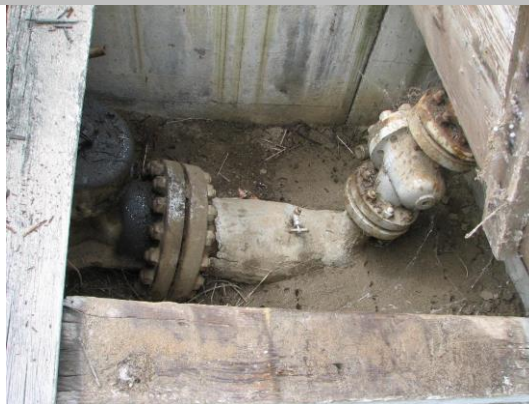
Photo 2 of 3 : UCIP\_SP\_2018\_52257\_37677.jpg

Inside view of vault located on the LS.

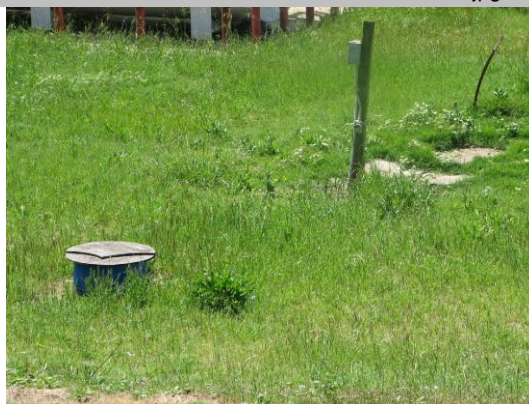
Photo 2 of 3 : UCIP\_SP\_2018\_52259\_37711.jpg

Stand pipe (potential observation well) and concrete pad located on LS.

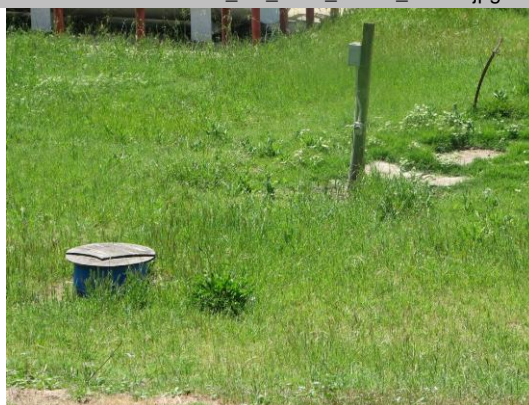
Photo 2 of 2 : UCIP\_SP\_2018\_52260\_37716.jpg

Electrical connection visible next to concrete pad--right corner.

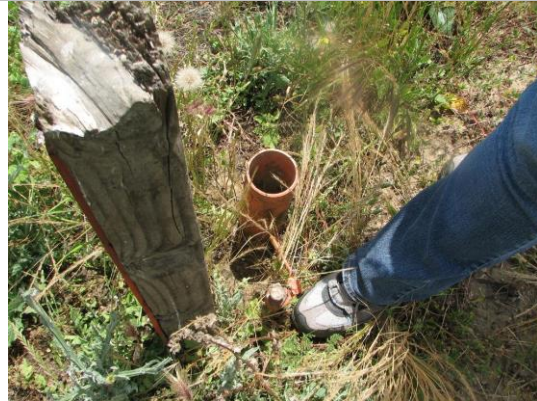
Photo 2 of 3 : UCIP\_SP\_2018\_52265\_37747.jpg

Small stand pipe (primer) located on LS--unknown purpose of stand pipe.

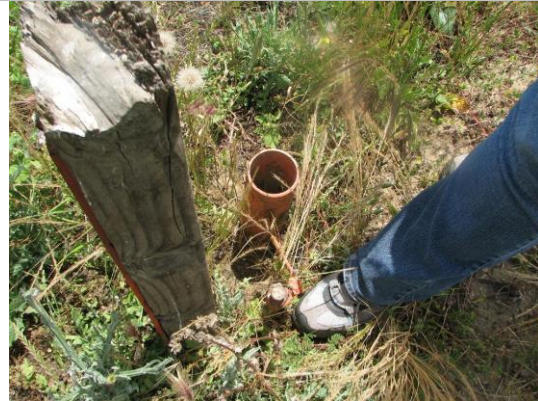
Photo 2 of 3 : UCIP\_SP\_2018\_52266\_37755.jpg

Small stand pipe (primer) located on LS--unknown purpose of stand pipe.

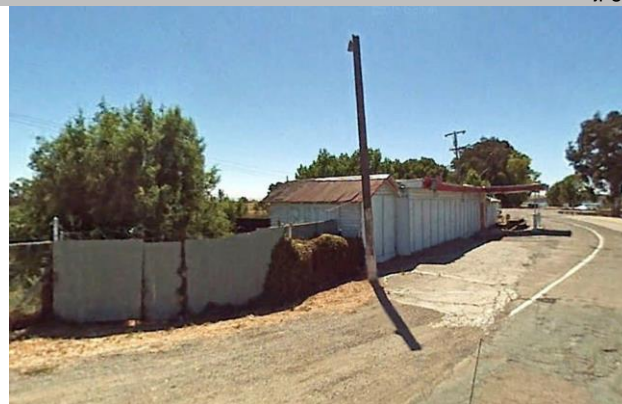
Photo 1 of 1 : SP\_2018\_RD0341\_167\_24\_20180305\_00004.jpg

Unpermitted landside building.

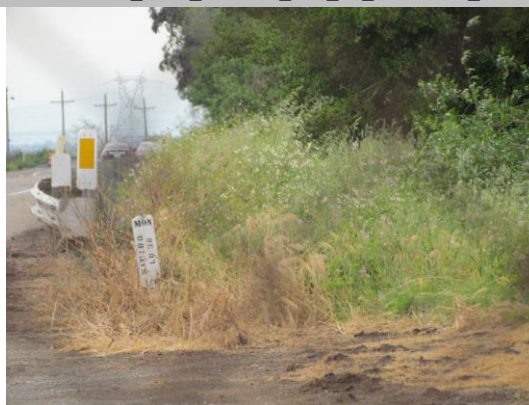
Photo 1 of 1 : SP\_2018\_RD0341\_168\_41\_20180305\_00009.jpg

Looking downstream from levee mile 3.94 at tall unwanted weeds and other vegetation on the waterside shoulder and slope.

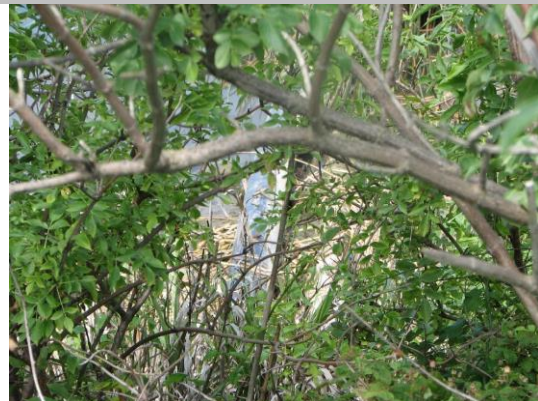
Photo 1 of 3 : UCIP\_SP\_2018\_22203\_37833.jpg

Limited access to waterward side--pipe visible through brush.

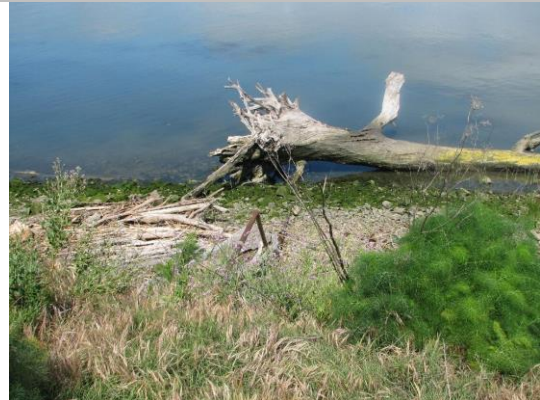
Photo 1 of 2 : UCIP\_SP\_2018\_22186\_37787.jpg

View of crossing on waterward side--dense vegetation on slopes.

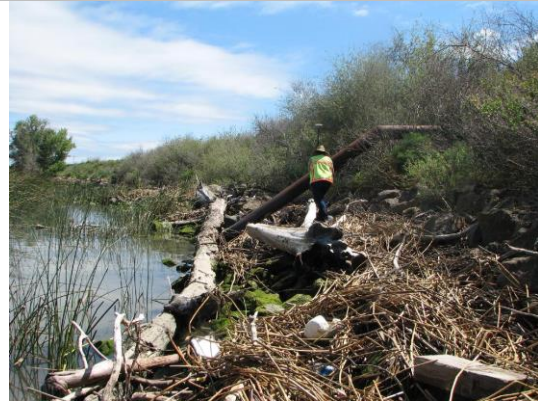
Photo 1 of 2 : UCIP\_SP\_2018\_50009\_37842.jpg

View of crossing on waterward side. Dense vegetation limits inspection of crossing.

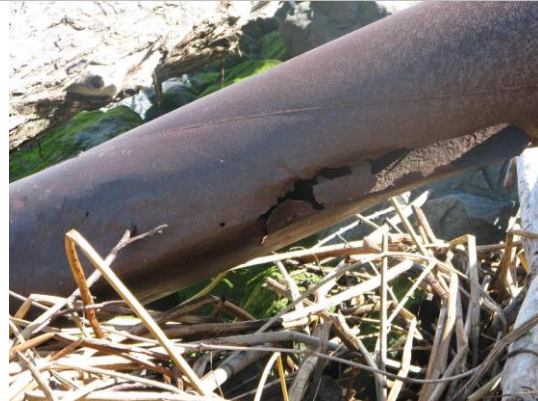
Photo 2 of 2 : UCIP\_SP\_2018\_50009\_37841.jpg

Holes present on waterward side.

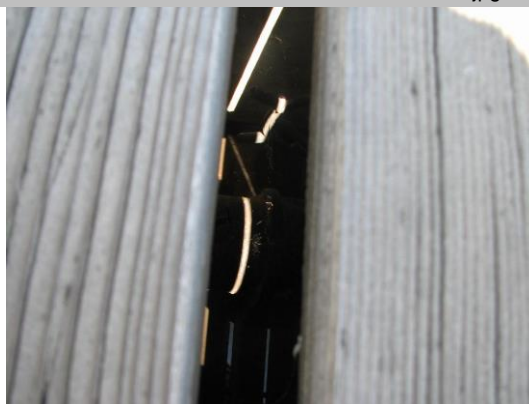
Photo 2 of 3 : UCIP\_SP\_2018\_22264\_37964.jpg

Unable to confirm the number of pipe through section of levee.

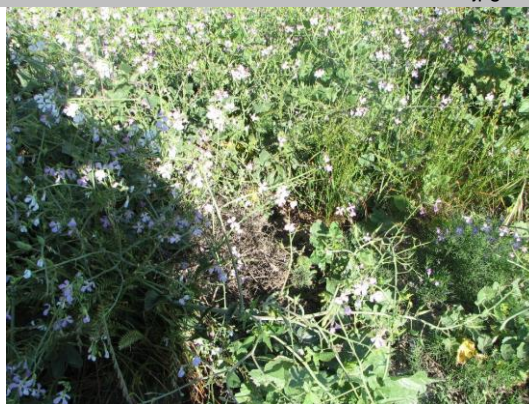
Photo 2 of 3 : UCIP\_SP\_2018\_22324\_38095.jpg

Potential subsidence in slope however difficult to determine due to dense vegetation.
